# Manhole Inspection Summary

Manhole # S21AA\_021MH

**Location** Address: **800 FULTON AVE**

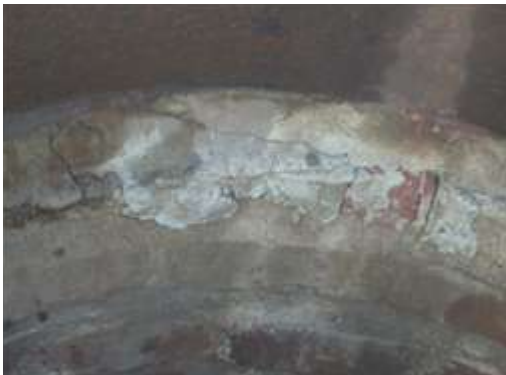
Defect 3

Offset: **1** (in.)

Condition: ☐ Sound ☒ **Cracked** ☐ Root Intrusion ☐ Loose Brick ☒ **Deteriorated**

FRAME OFFSET AND CRACKED  
CHIMNEY

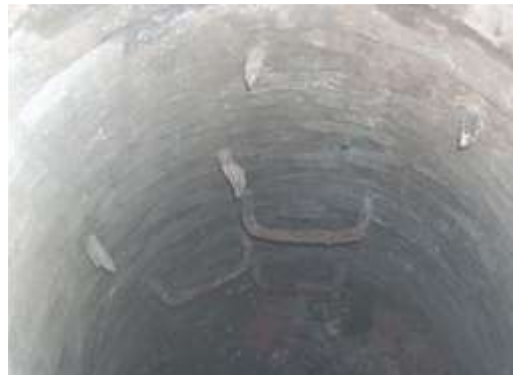
Defect 2

Count: **3** Missing: **2** ☒ **Corroded**

CORRODED AND MISSING STEPS

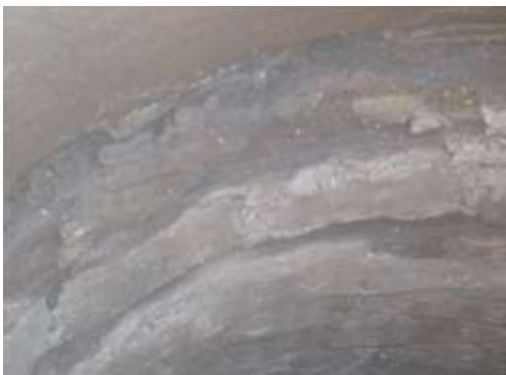
Defect 1

DETERIORATION OF CHIMNEY

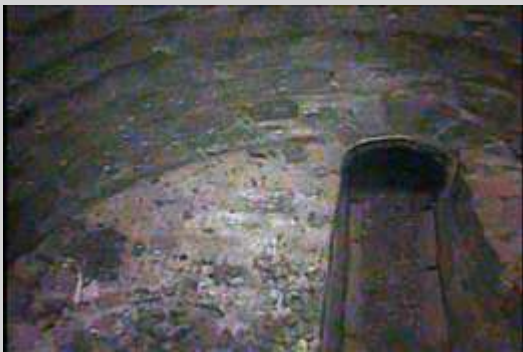
12 O'Clock Outflow

8 in. Circular Gravity Sewer  
Pipe Out @ 12 O'Clock

Pipe Height: **8.4** (in.) Rod and Bar (Angled)  
Pipe Material: **Clay** ☐ Pipe Lined  
Invert Depth: **9.65** (ft.) Flow Characteristics: **Slow**  
Deposits: ☒ None ☐ Mud ☐ Sludge ☐ Debris ☐ Grease  
Silt Depth: (in.) Deposits Extent:  
Infiltration: **None** Pipe Seal Cond: **Sound**

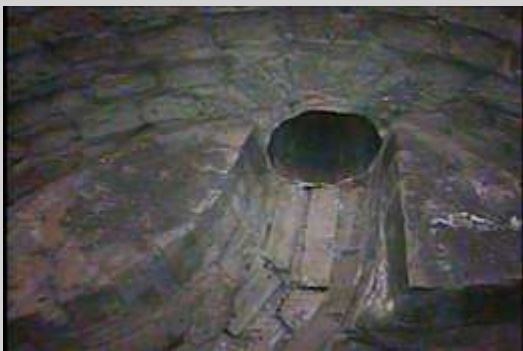
3 O'Clock Inflow

8 in. Circular Gravity Sewer  
Pipe In @ 3 O'Clock

Pipe Height: **8.4** (in.) Rod and Bar (Angled)  
Pipe Material: **Clay** ☐ Pipe Lined  
Invert Depth: **9.21** (ft.) Flow Characteristics: **None**  
Deposits: ☒ None ☐ Mud ☐ Sludge ☐ Debris ☐ Grease  
Silt Depth: (in.) Deposits Extent:  
Infiltration: **None** Pipe Seal Cond: **Sound**

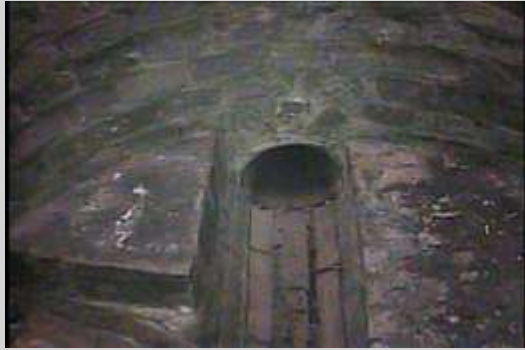
6 O'Clock Inflow

8 in. Circular Gravity Sewer

Pipe In @ 6 O'Clock

Pipe Height: **7.2** (in.) Rod and Bar (Angled)

Infiltration: **None** Pipe Seal Cond: **Sound**
